# Manhole Inspection Summary

Manhole # S51M\_\_002MH

Insp Date: **4/14/08 11:41 AM**

**Location** Address: **2912 s linwood curely**

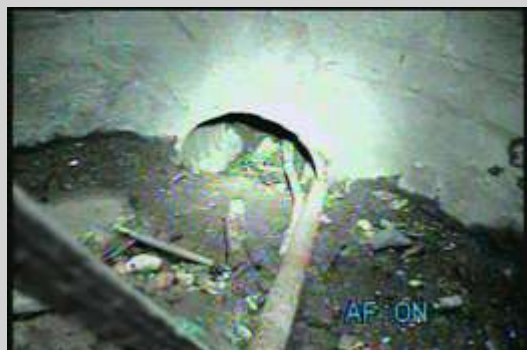
12 O'Clock Outflow

8 in. Circular Gravity Sewer  
Pipe Out @ 12 O'Clock

Infiltration: **None** Pipe Seal Cond: **Unknown**
